MUD RUN, PASSAIC COUNTY

PHASE I INSPECTION REPORT

NATIONAL DAM SAFETY PROGRAM

NJ 00222

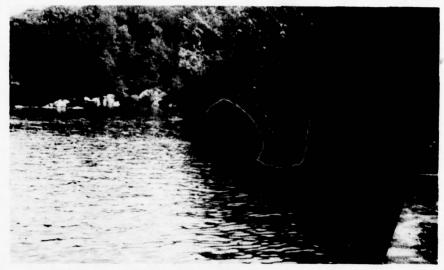
VIEW OF GRAVITY SECTION LOOKING TOWARDS EARTH EMBANKMENT

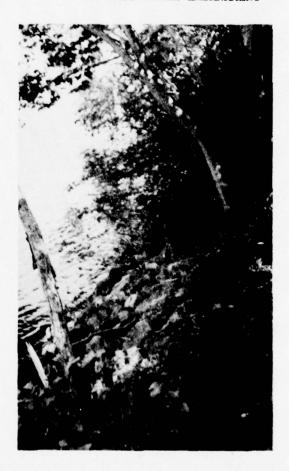
The earth embankment section, with uneven top, irregular sideslopes and dense cover of trees and brush, is also in poor condition. Dense tree growth on the entire embankment jeopardizes the integrity and safety of the embankment as the root system of the trees may penetrate deeply to and even through the concrete core wall. After the death of the tree and decay of the root system, voids will be left in the embankment.

SLOPE PROTECTION OF EARTH EMBANKMENT May 1978

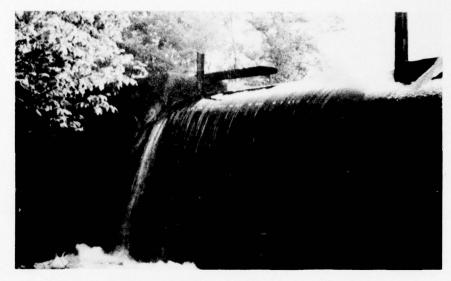
### SPILLWAY WITH ONE FLASHBOARD

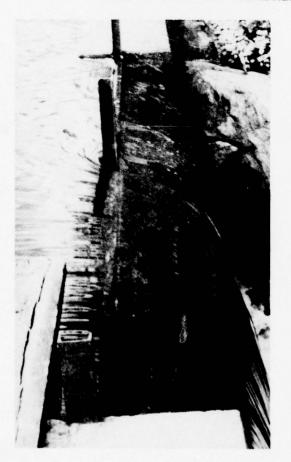
RIGHT SPILLWAY ABUTMENT

- a. Concrete Gravity Section The right spillway abutment showed a 1/2 inch wide surface crack running from near the spillway crest to the abutment rock at 45°; there was no seepage observed along the crack. A horizontal crack was observed over the full length of the 20-foot spillway section; however, discharge water prevented closer investigation of this crack. At the last horizontal change in direction of the dam, 79.5 feet south of the spillway, the concrete was cracked through the crest and downstream side, and has been strengthened through addition of extra concrete on the upstream side. Apparently the repairs and additional concrete were necessary because of extensive structural cracking. No vertical or horizontal alignment deviation was noted at the cracked areas. This area also shows signs of having been overtopped as indicated by erosion marks along the concrete dam toe. The section north of the spillway shows extensive scouring of soil along the toe of the dam, up to 36-inches depth in places.

- 6. Structural cracks and cracks in the cement mortar cover of the concrete gravity section should be further investigated and repaired soon.

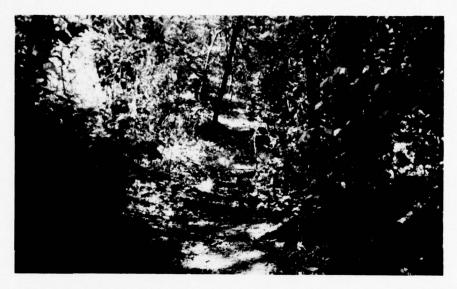
EARTH EMBANKMENT LOOKING NORTH

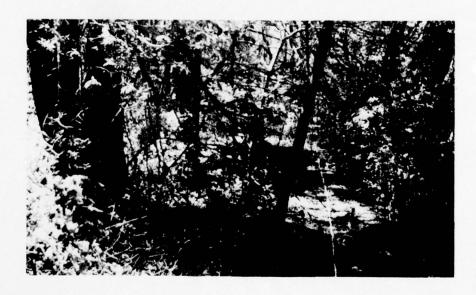
EARTH EMBANKMENT LOOKING NORTH
